# KENWOOD

## SERVICE BULLETIN

SUBJECT	DATE
TS-430S 500KHZ Hetrodyne	3.23.83

Some users of the TS-430S have reported a hetrodyne signal at the 500KHZ point on the band. This tone may be reduced or eliminated by the following procedure.

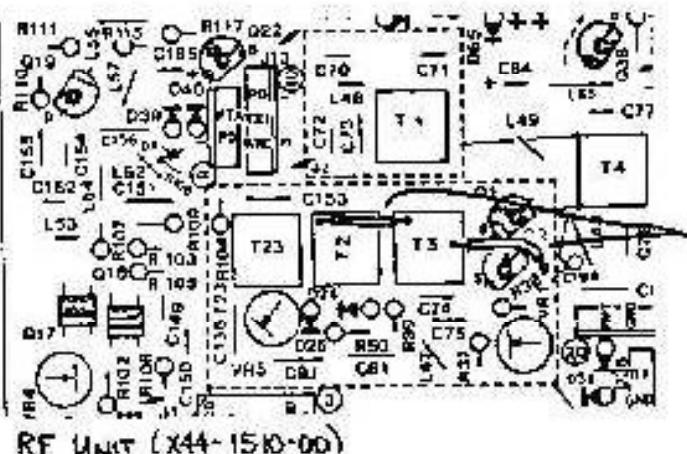
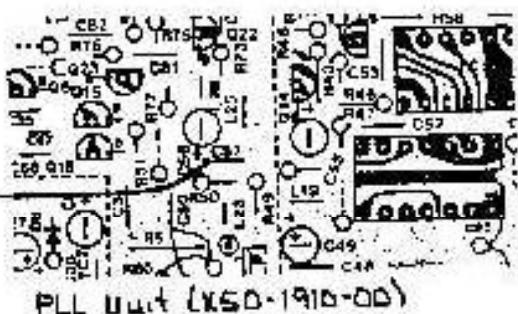
For reports of an internal beat at 28.415 Mhz or at 21.526 Mhz perform the following modification.

1. On the RF Unit (X44-1510-00) add a short jumper wire from the primary ground of transformer T2 to the primary ground of T3 as shown.
2. Add a jumper from the ground of the secondary of T3 to the ground side of capacitor C194, as shown.
3. Solder a jumper from the shield surrounding T1 to the shield surrounding T2, T3 etc. It may be possible to just bridge the two cases together with solder, either way is acceptable.
4. On PLL Unit (X50-1910-00) locate the position shown for capacitor C57. This capacitor was not installed at the factory, install a .01 uf 25v disc ceramic capacitor.

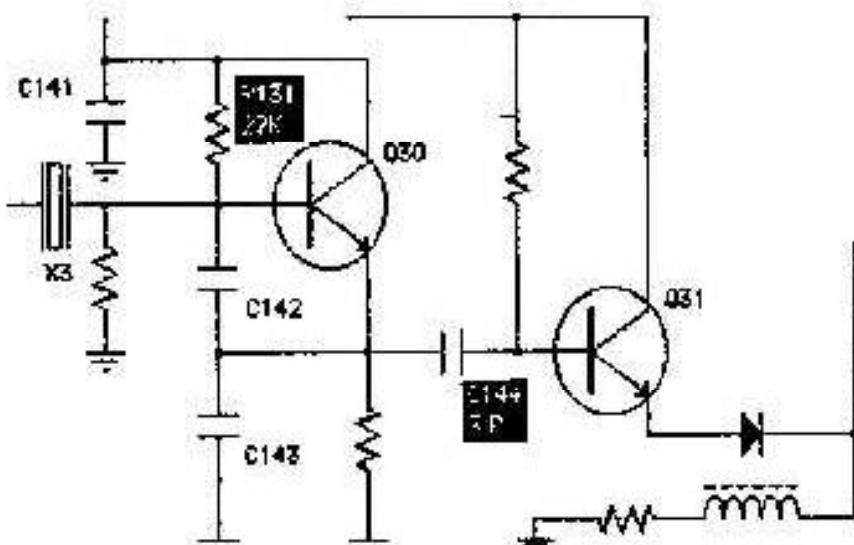
Some owners of the TS-4305 have reported intermittent loss of Transmit and Receive when operating in the FM or AM modes, along with a loss of the Digital Display.

The cause of this may be due to a loss of the FM/AM Heterodyne Oscillator signal. Replacing the components listed below will correct most instances of this failure.

On the CONTROL UNIT (X53-1290-00) change R131 to a 22 K $\Omega$  1/4 watt carbon resistor (RD14CB2E223J), and change C144 to a 3 pF 25 v disc ceramic capacitor (CC45SL1H050C).

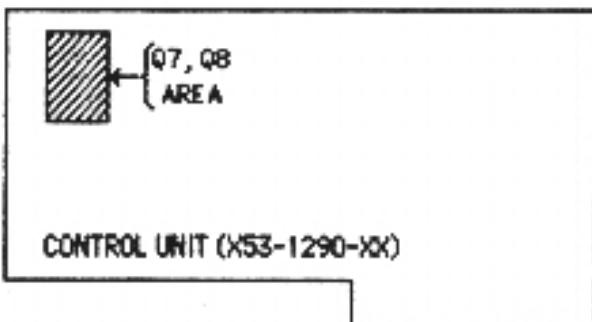
This service bulletin supersedes bulletin 891, which concerned low input levels to IC-16 as the radio warmed up. This bulletin incorporates information contained in Bulletin 891 plus additional information.

Check transistor Q8. If it is not a 2SC1815(Y) change it to this type (Serial numbers 408XXXX-509XXXX).

For serial numbers before 408XXXX change R29 to 820.0  $\Omega$  and C41 to 100 pF.

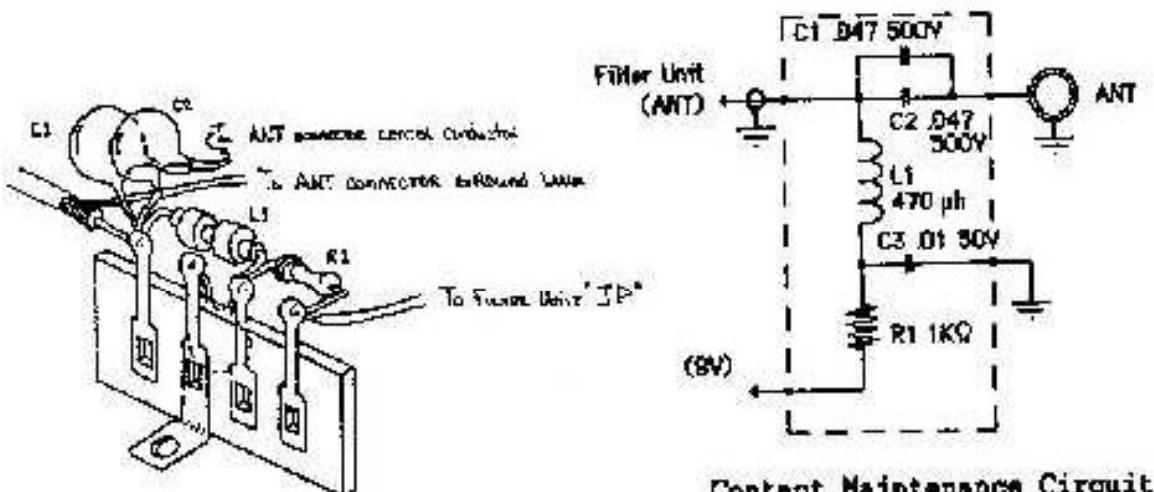
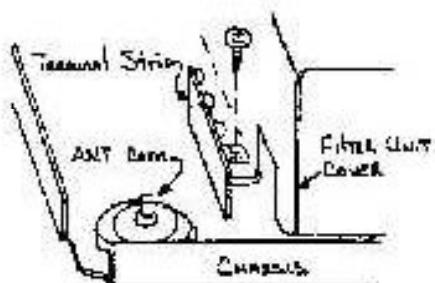
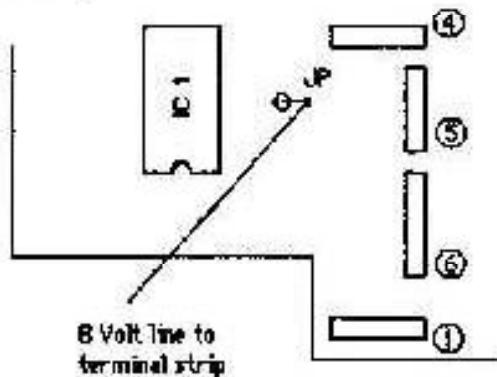
SUBJECT	DATE
TS-430S LOW/INTERMITTENT RX	10-10-85
<p>Low or intermittent receive on the TS-430S may be caused by a poor contact on one or more of the LPF relays. In most cases the following procedure will correct this problem without having to replace relays. The procedure has two steps, first initial cleaning of the contacts by passing a relatively high current thru them (about 500 mA), and then installing a contact maintenance circuit that will apply a relatively low current (about 8 mA) whenever a new band is selected.</p>	
<p><b>PROCEDURE:</b></p> <p>I. Initial contact cleaning procedure.</p> <p><b>Parts List:</b></p> <p>560 SW Ceramic Resistor (R92-0622-05).....2 ea.</p> <ol style="list-style-type: none"><li>1. Press and hold the "LP" bandswitch of the TS-430S (ensure the 1 Mhz switch is ON).</li><li>2. Apply 13.8 vdc to the antenna terminal thru a 28 Ω, 10 W resistor for approximately 1 minute. This will cycle thru all the relays and burn any oxidation/contamination from the contacts.</li></ol>

1. Disconnect the center lead of the coaxial cable from the antenna terminal.
2. Install the contact maintenance circuit as shown in the accompanying diagrams. Attach the terminal lug strip with one of the filter unit cover screws.
3. Solder the 8v lead to the "JP" terminal of the Filter Unit.
