# KENWOOD

SB-959

## SERVICE BULLETIN

SUBJECT	DATE										
TS-950SD SPEECH PROCESSOR NOISE	01/12/90										
<p>When the Processor-In control is set to some level below 10dB of compression, a crackling noise can be induced on the transmit signal. The following modification will reduce the noise. After the modification has been performed, the noise can only be heard when the Processor-In control is set too low to be functional.</p>											
<p>NOTE: This modification has already been performed on models starting with serial number 0120441.</p>											
<p>REQUIRED PARTS:</p>

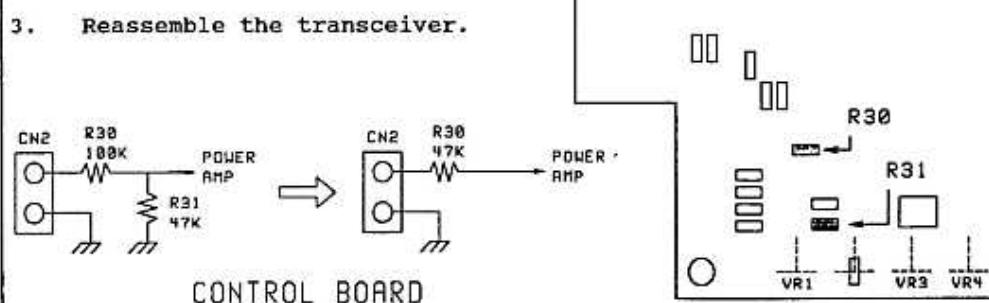
Early TS-950S Digital transceivers will not produce sufficient audio from the optional VS-2 voice synthesizer. The following modification will correct this condition.

1. Desolder and discard chip resistors R30 and R31.
2. Install a 47K ohm chip resistor in place of R30. Do not use R31 (47K ohm) in the R30 position. Use a new resistor.
3. Reassemble the transceiver.

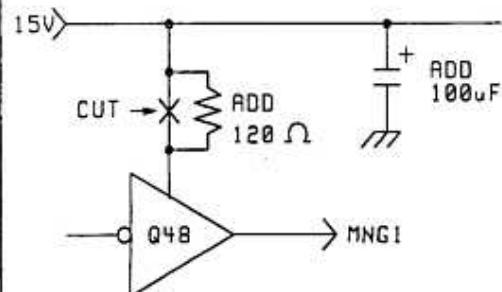
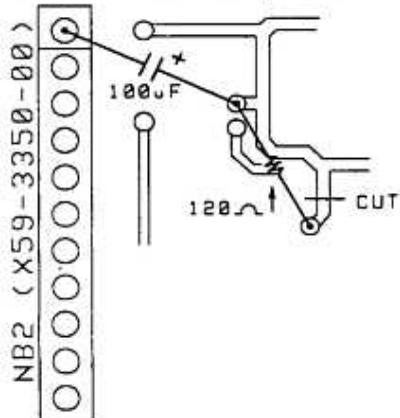
Switching noise from the main band noise blower circuit may be induced on the 15V line and pass through the AF amplifier to the speaker. The following modification will correct this condition.

1. Cut the foil as shown in the accompanying diagram.
2. Add a 120 ohm resistor between the emitter of Q48 and the 15V line.
3. Add a 100uF, 16V capacitor between the 15V line and ground.

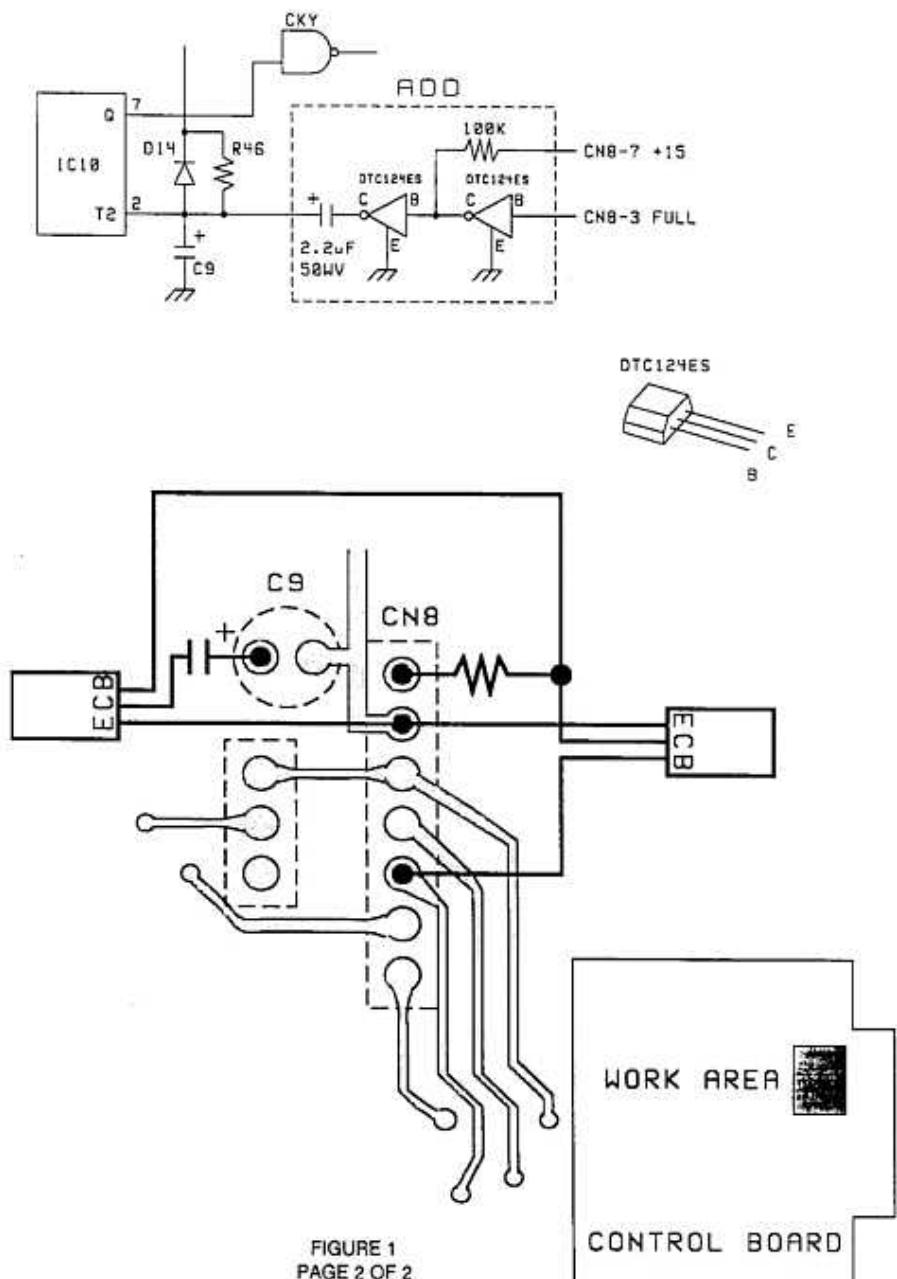
The TS-950SD RX to TX switching time in semi break-in is approximately 10mS. At key down, the transceiver momentarily sees an open circuit because the linear's keying relay has not engaged. As a result, the transceiver's protection circuit turns on, causing the output power to be reduced. The following modification will make the RX to TX switching time, in semi-break-in, approximately 30mS. This modification does not affect full break-in switching. Increasing the switching time to 30mS may restrict certain long distance high speed communications.

1. Disconnect the power cord and antenna.
2. Remove the top and bottom covers (18 screws).
3. Remove the top screw from each side of the front panel assembly.
4. Loosen the bottom screw on each side of the front panel assembly.
5. Pull the front panel assembly forward to expose the Digital and Control boards.
6. Remove the two screws that secure Control board B/3 to the top of the chassis and swing the board out of the way.
7. Remove the 4 screws from Control board A/3 and rotate the board down. Disconnect the right hand plugs as necessary to expose the foil side of the Control board.
8. Install the circuit shown in figure 1 on the foil side of Control Board A/3.
9. Assemble the transceiver by reversing steps 1 - 7.

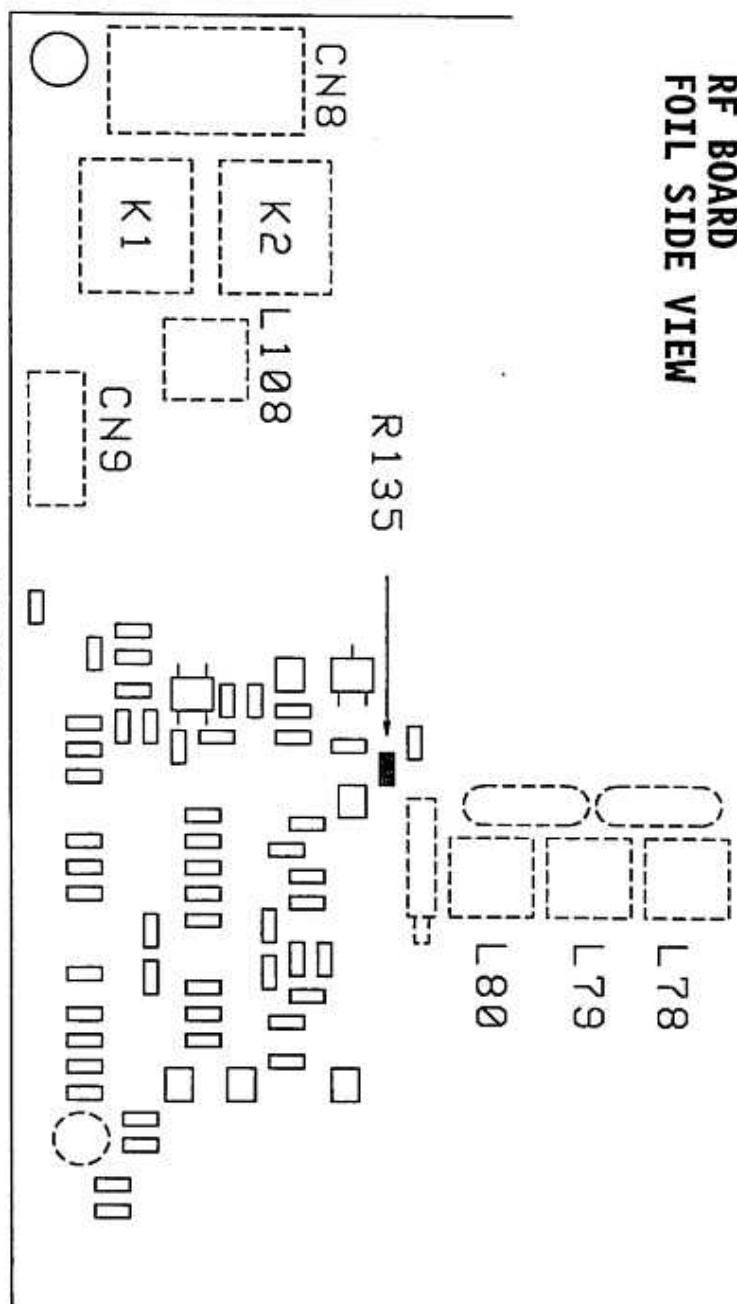
FIGURE 1

When the MONI switch is turned on, transmit power may not develop for two seconds after key down. During this time, the ALC meter will pin and the SWR meter will read high. This will more likely develop on 18MHz and 21MHz bands. The following modification will correct this condition.

1. Disconnect the power cord and antenna.
2. Remove the top and bottom covers (18 screws).
3. Locate the RF unit on the bottom of the transceiver. This is the back left board of the four boards on the bottom of the transceiver.
4. Remove the RF board shield plate (4 screws).
5. Remove the 3 remaining screws from the RF board.
6. Remove the black screw that secures the DRIVE OUT/RX ANT IN jack to the back panel.
7. Disconnect the right hand coax cables from the RF board and unplug connector #2.
8. Slide the RF board forward and then rotate it towards the front of the transceiver to expose the foil side of the board.
9. Locate chip resistor R135 as shown in figure 1.
10. Replace R135 with a 2.2K ohm chip resistor.
11. Assemble the transceiver by reversing steps 1 - 8.

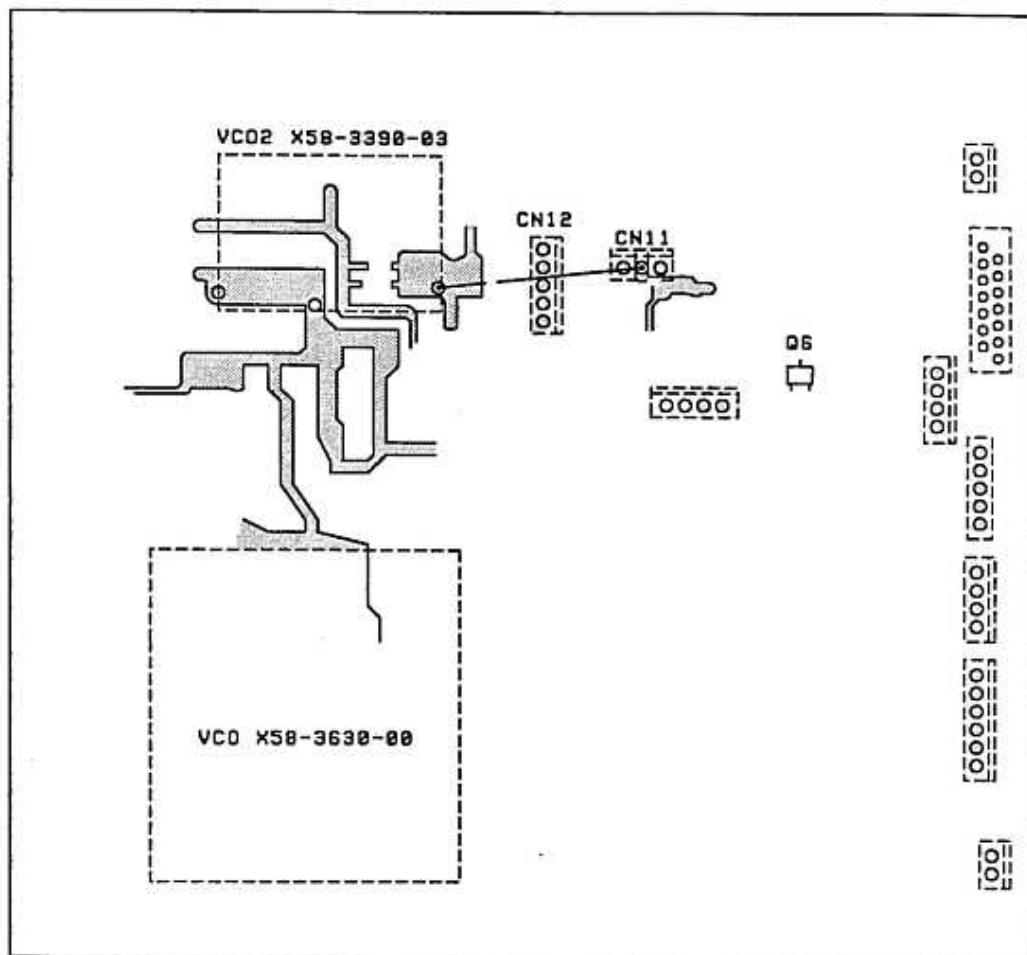
AF UNIT X49-3020-00

About 1mV of noise is present at the speaker or headphone jack in the receive mode with the AF GAIN control set to minimum. If the transceiver is in the CW mode, a faint tone might also be heard through the headphones (sidetone leakage). The following modification will reduce the level of the noise and the tone.

1. Disconnect the power cord and antenna.
2. Remove the top and bottom covers (18 screws).
3. Locate the AF unit on the bottom of the transceiver. This is the front left board of the four boards on the bottom of the transceiver.
4. Remove the screws from the AF unit and disconnect the plugs as necessary to turn the board over to expose the foil side of the board.
5. Replace Q6 with a 2SD1757K(S).
6. Solder a 22 AWG jumper wire as shown in figure 1.

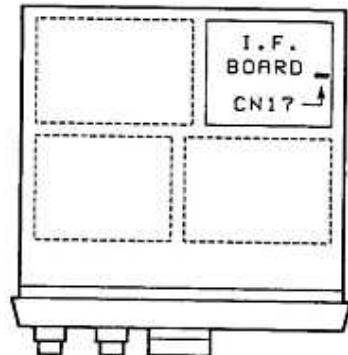
FIGURE 1

Some TS-950SD owners have reported a transmit image at 18.115MHz that causes the receiving station to hear distortion on the carrier. If the operating frequency is shifted 3KHz above or below 18.115MHz, the image disappears. This modification will lower the image level from -30dB (worse case) to better than -40dB by installing a trap on the 455KHz I.F.

1. Disconnect the power cord and antenna.
2. Remove the top and bottom covers (18 screws).
3. Locate the I.F. board on the bottom of the transceiver. This is the back right board of the 4 boards on the bottom of the transceiver. Figure 1
4. Locate L36 by connector CN17 on the I.F. board. Figure 2
5. Install and solder into place a 4pF trimmer capacitor across L36. Figure 3
6. Install a 2.2uH coil and 40pF trimmer capacitor in series from the output of L36 to ground. The can of L31 can be used for ground. Figure 3

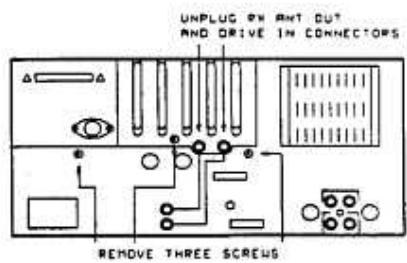
FIGURE 2

Some TS-950SD owners have reported a transmit spurious emission between 3.500MHz and 3.520MHz. This modification will reduce the spurious emission to -65dB.

1. Disconnect the power cord and antenna.
2. Remove the top and bottom covers (18 screws).
3. Open the subchassis to expose the PLL board (Figures 1-3). To open the subchassis remove 4 top screws, remove 3 back panel screws, and unplug the RX ANT OUT and DRIVE IN connectors.
4. Replace the four VCO shield plate screws with the type listed above. Figure 3
5. Close the subchassis and secure it with the screws removed in step 3.
6. Locate the A.F. board on the bottom of the transceiver. Figure 4
7. Remove the board's mounting screws and disconnect the necessary connectors to expose the bottom of the board.
8. Locate the foil pattern area shown in Figure 5. This area is below IC11.
9. Cut the foil pattern and add the components shown in Figure 6.
10. Assemble the transceiver. Remember to plug in the two connectors on the back panel.

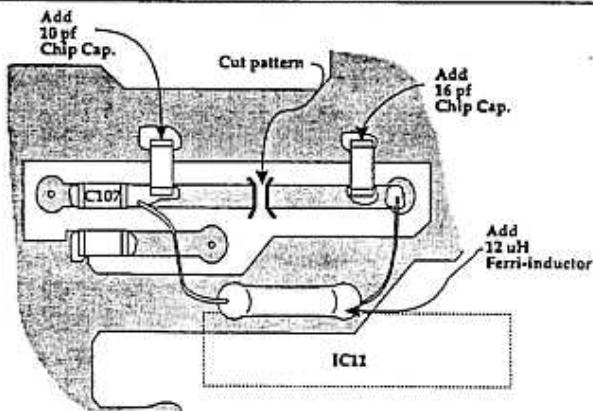
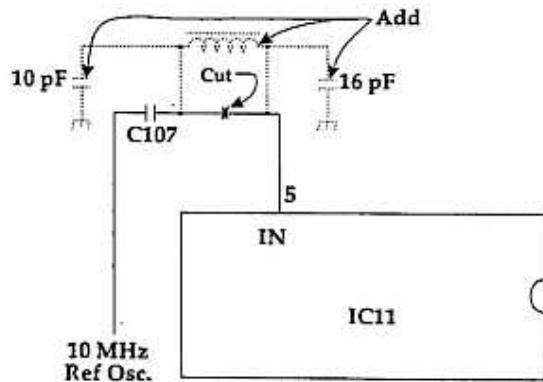
AF Unit (X49-3020-00)  
Foil Side View

A transmitter spur might be present at a dial frequency of  $\underline{\underline{X}}.\underline{\underline{X}}\underline{\underline{X}}1$  MHz. This spur ( $f_0 \pm 1$  kHz) is quite small (-55dB relative to  $f_0$ ) but might become noticeable when the transceiver is used with a linear amplifier.

The transmitted signal enters pin 5 of IC11 which is in the last PLL loop in the AF unit due to RF feedback. This pin is the input for the 10 MHz Ref Osc signal from the CAR unit. IC11 is the source of the spurious signal since both the band and 10 MHz frequencies are divided by the 500 kHz comparison frequency supplied by IC11.

To reduce this RF feedback increase the Ref Osc level from .2V to .7V rms by adding the accompanying circuit to the input of IC11.
